# AN6442

## IGBT Module Failure Mechanisms

### Application Note

AN6442-2 July 2024 LN43471

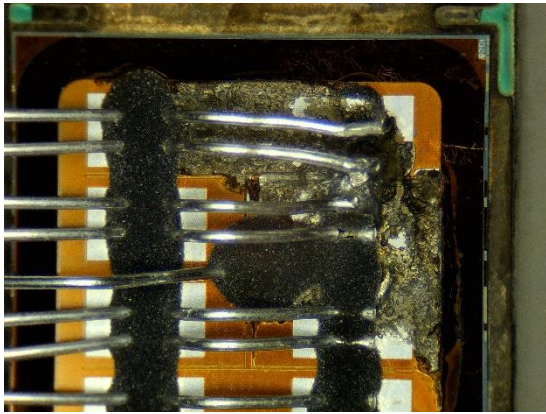
Significant overcurrent can result from internal or external faults, improper control actions, or unexpected load events, and its effect is often sudden and leads to thermal runaway, defined in section 3.2.1. Overheating from significant overcurrent failure mechanism can be categorised into the following types.

**Figure 2. Overcurrent failure.**

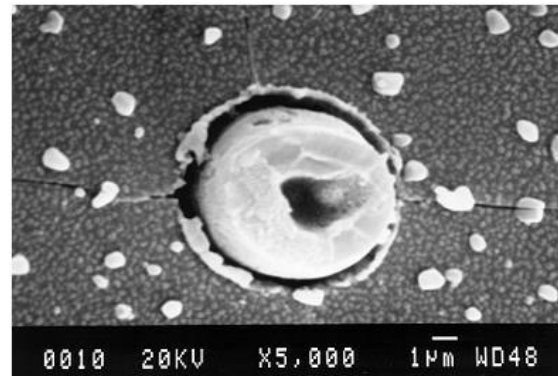
energetic particles generated in the upper atmosphere due to Cosmic Rays from space pass through a semiconductor device, they can collide with silicon atoms. This can create electron-hole pairs which may be multiplied many times through impact ionisation. The generation of these free charge carriers can lead to current pulses within the semiconductor material. These current pulses can potentially disrupt the normal operation of the semiconductor device, leading to permanent damage to the chip. **Figure 3** shows a typical failure site due to cosmic ray.

**Figure 3. Burn out as a result of a neutron impact.**

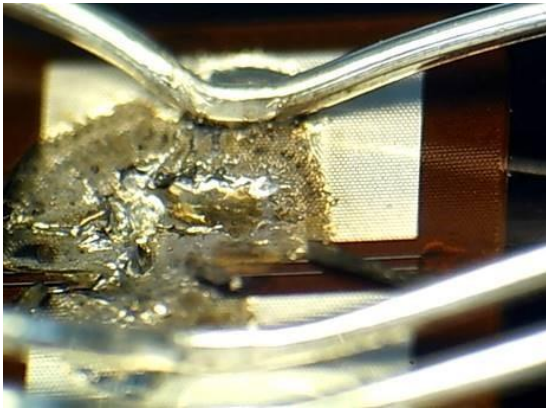
High temperature can lead to destruction of the chip due to variation of Temperature Sensitive Electrical Parameters (TSEP). For example, threshold voltage,  $V_{th}$ , which generally reduces with increasing temperature. If the  $V_{th}$  fall below the built-in voltage,  $V_{bi}$ , of the junction then a latch-up type fail can be seen. Furthermore, the maximum temperature that the chip can tolerate is limited by the Intrinsic Temperature. Above the intrinsic temperature current filamentation & failure can be expected. Improper operation of the cooling system, degradation of the Thermal Interface Material (TIM) via pump-out, and abnormal high ambient temperature can lead to high junction temperature of the IGBT.

**Figure 4. Thermal excitation failure.**

A key contributor to temperature rise is a TIM with raised thermal resistance, often due to improper mounting or the use of substandard thermal grease. Such conditions may subsequently lead to localised overheating within the material stack, potentially resulting in premature module failure. **Figure 4** shows melting of chip metallisation and die-attach solder due to high temperature.

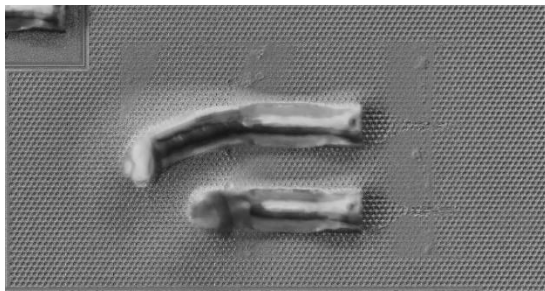
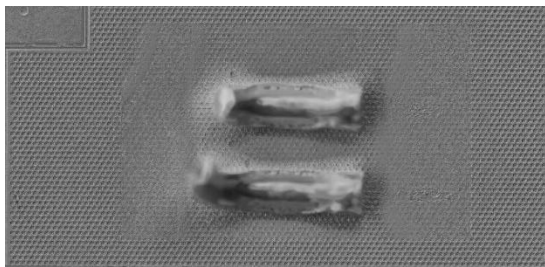
Due to the temperature cycling, tensile or compressive forces are imposed on the thin metallisation layer, which typically is an aluminium metal applied on the chip surface. Stress arises from the difference between the thermal expansion of the chip and the metallisation layer. Under extreme conditions the metallisation layer may melt and resolidify due to localised temperature fluctuations; that is, the reconstruction phenomenon occurs. This impacts the function of the metallisation layer by reducing its ability to distribute the current across the whole chip.

**Figure 5. Metallisation degradation failure. (a) Before. (b) After.**

This increases the on-resistance of the IGBT module and indirectly increases the on-voltage drop of the IGBT. The power loss of the module will increase, and the junction temperature will also increase, which is not conducive to the reliable operation of the IGBT module. **Figure 5** shows metallisation degradation as a result of temperature cycling.

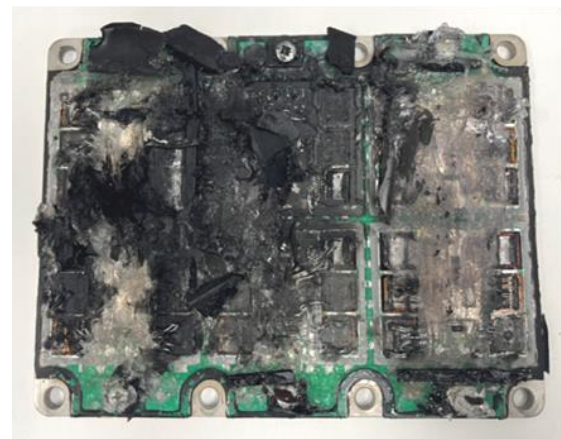
**Figure 6. Thermal runaway failure.**

Thermal runaway in an IGBT module occurs when the heat generated by the device exceeds the cooling system's capacity to dissipate it, leading to a self-reinforcing cycle of increasing temperature of the package. Failure in the cooling system or control system, overvoltage, and overcurrent (particularly short-circuit current) may lead the module to thermal runaway which can quickly destroy (melt) IGBT module's components such as chip, bond wires and solder joints. **Figure 6** shows the extensive destruction of an IGBT module as a result of thermal runaway.

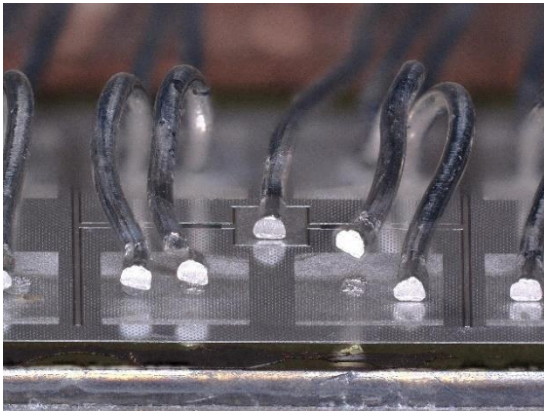
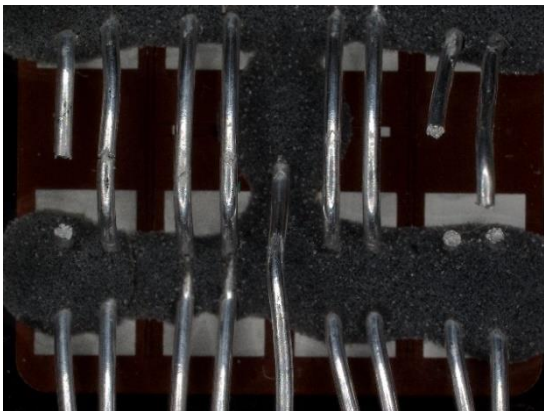
**Figure 7. Bond wire degradation due to thermo-mechanical fatigue. (a) Bond wire lift-off. (b) Bond wire heel cracks.**

As previously mentioned, the IGBT module is continually subjected to temperature cycling, as the forward conduction current flowing through it causes the temperature to rise, and the current dropping to zero leads to a temperature decrease. Because of the different coefficients of expansion between the package materials, temperature cycling inside the package results in thermomechanical fatigue. Therefore, thermo-mechanical fatigue in an IGBT module occurs due to repeated cyclic loading during its operational cycles. As a result of thermomechanical fatigue, bond wire can crack, and lift-off as shown in **Figure 7**. Other factors, such as fluctuations in ambient temperature and vibration, can accelerate this failure process.

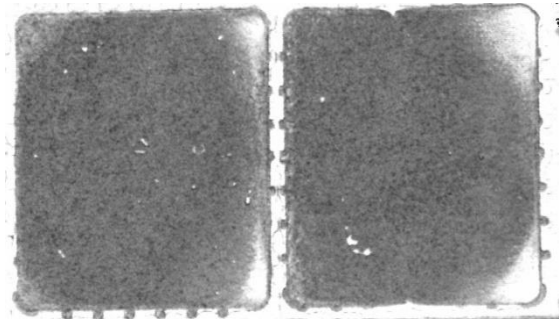
**Figure 8. Solder layer delamination due to thermo-mechanical fatigue.**

Under cyclical thermal stress, the solder layer gradually develops cracks and voids, and eventually, solder layer delamination may occur [9] [10], as shown in **Figure 8**. Thermomechanical creep in an IGBT module is associated with prolonged exposure to increased temperatures during operation. The constant application of high temperatures can induce slow, time-dependent deformation in the materials, particularly in solder joints and other critical components. This deformation may lead to the gradual deterioration of the module's structural integrity, impacting its overall performance and reliability.

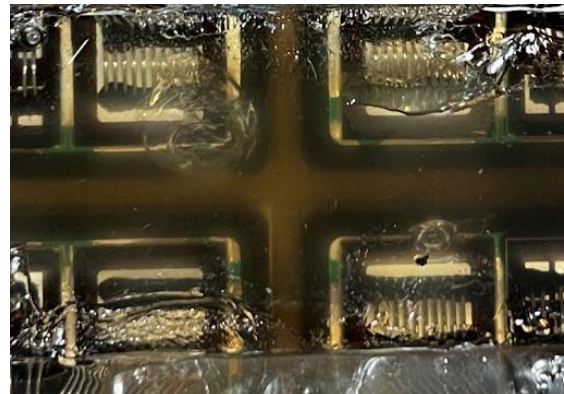
and environmental stresses. For example, partial discharges at the interface between the ceramic and metal layers produce small discharge activity, while the partial discharges at the metal edges might be in the range of a few nC, leading to the decomposition of silicone gel into gaseous products and reducing the insulating capability of the material. In addition, humidity severely degrades the insulation characteristics of the module encapsulation materials such as silicone gel, particularly at high temperature and long-term voltage application. **Figure 9** shows gas bubbles formation in silicone gel.

**Figure 9. Gases bubbles in silicone gel due to surface corrosion.**
